## পরীক্ষণ ও গ্রহণ কমিটির রিপোর্ট

| কাজের নাম | ঃ “Procurement of Submersible Mixer with related spare parts and Spare parts of Submersible Pump Motor for Dasherakandi STP, Dhaka WASA”. |

## INSPECTION REPORT

Inspection report no. S500243  
Report submission date: 16-02-2026

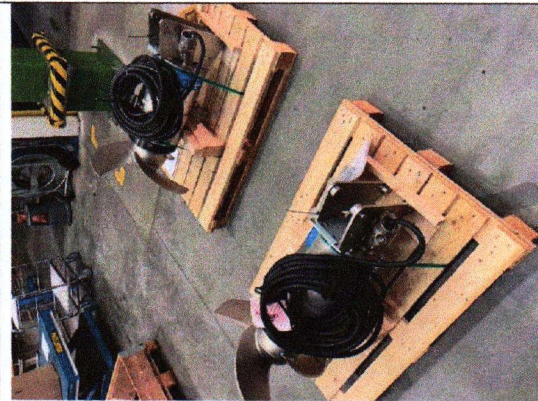
1. Overview 2 Pumps with cables

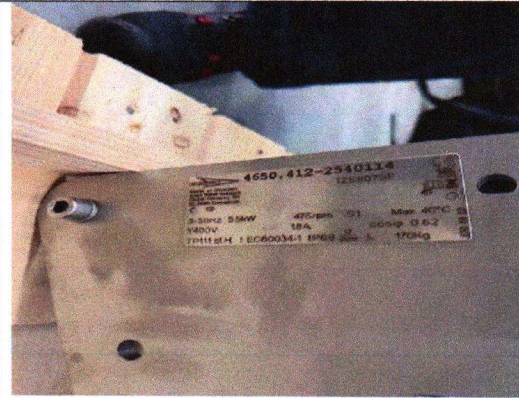
2. Name plate on pump

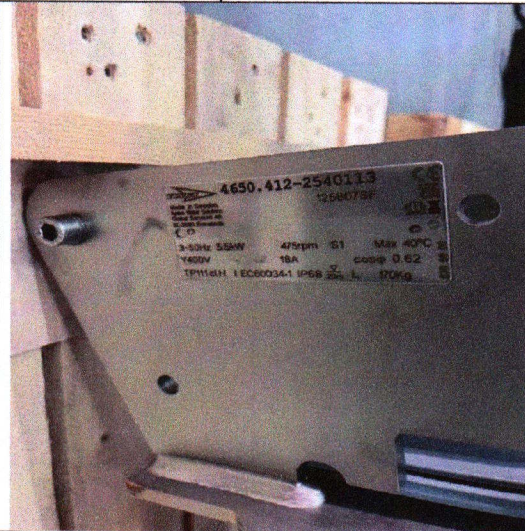
3. Name plate on pump

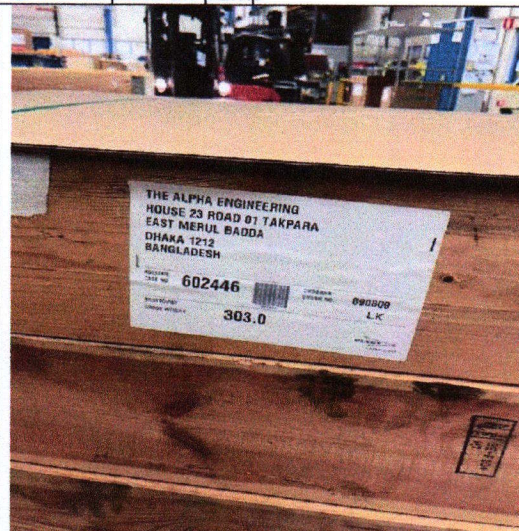
4. Marking on the pallets

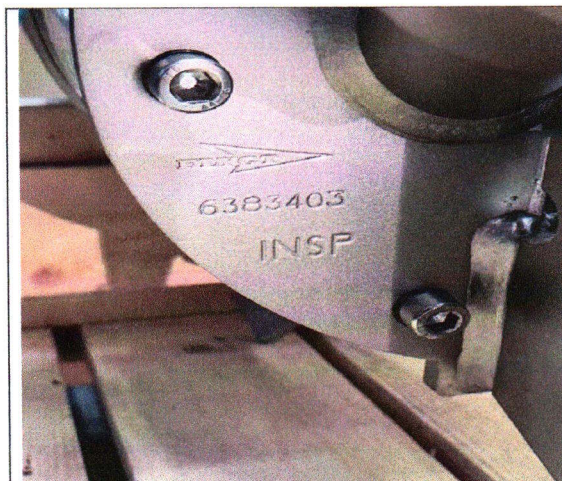
5. Marking on the pumps

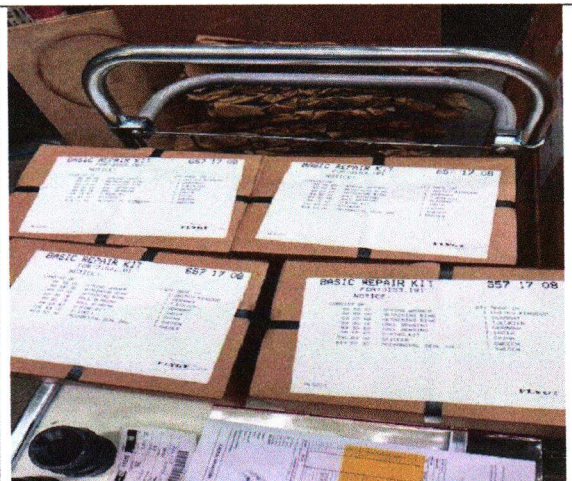
6. Marking on the boxes with repair kit

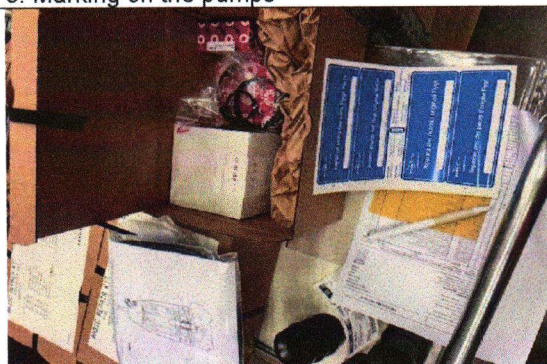
7. Random quantity control inside the box

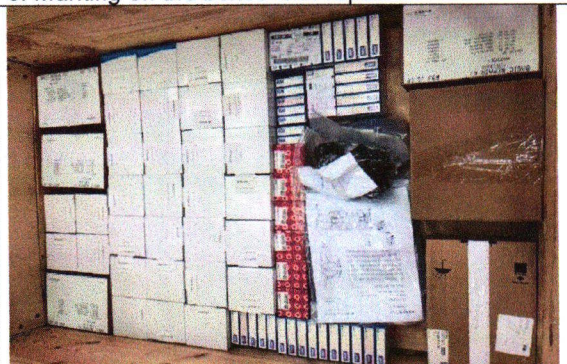
8. Overview inside the pallet with spare parts and repair kits

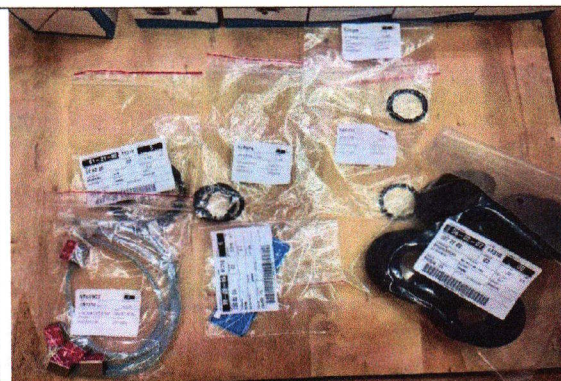
9. View of spare part during quantity check

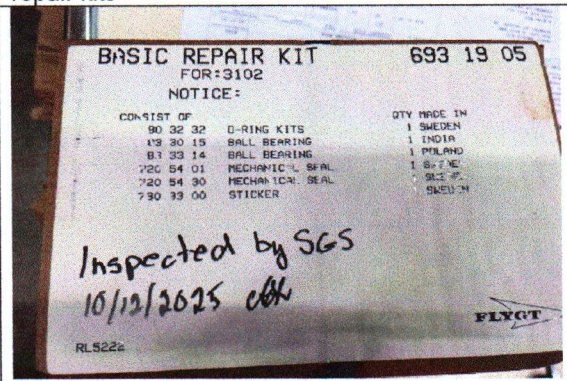
10. Marking on Box with repair kit
