Subject: Submission of Third Party Inspection Report and Verified Documents against the contract no. 46.05.0000.428.07.016.24/2024-25/eGP/C-11 for the supply of 25 mm (DN 25) Domestic Water Meter for Revenue Zone, Dhaka WASA.

Report No: IND435

Water Meter

DN25 mm multi-jet dry dial (IP68) Domestic Water Meter with mineral glass and pulse output cable 2mt  
with couplings (TK-3C) R160  
%5 Spare Parts.

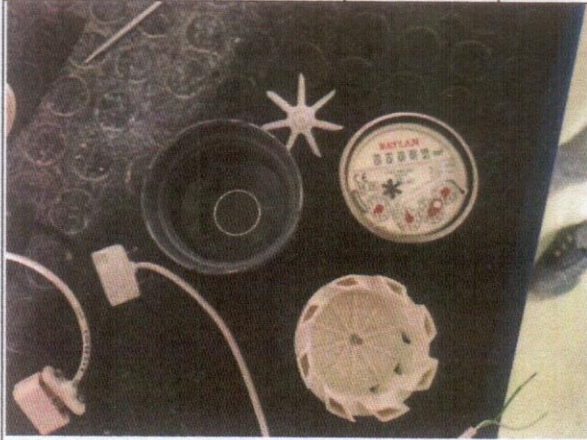
Disassembled mechanism of water meter

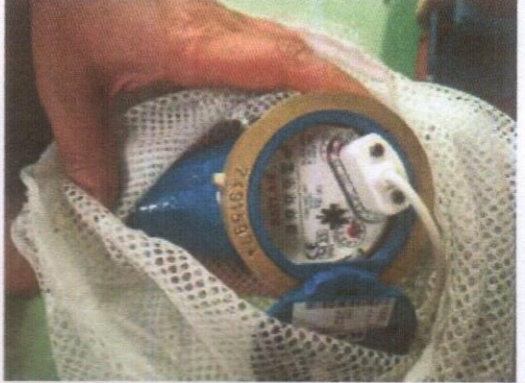
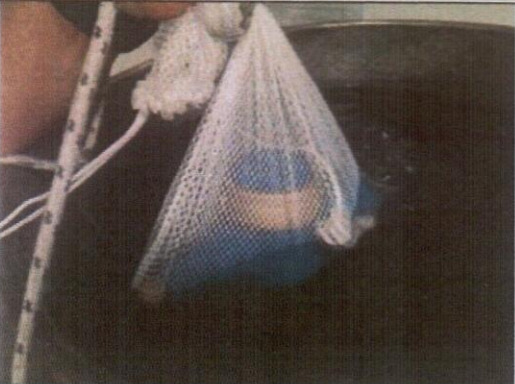
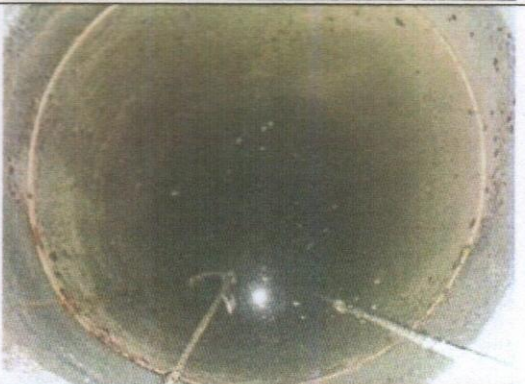
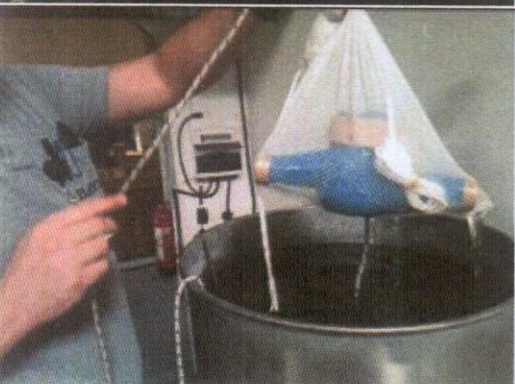
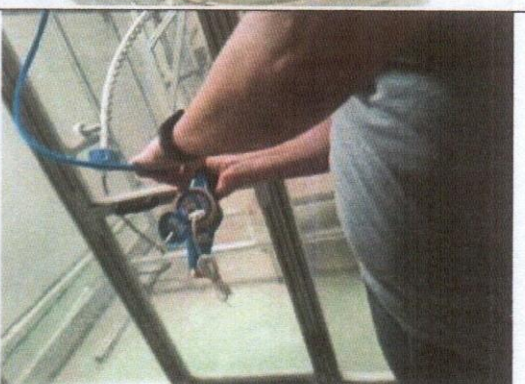
| 7 | Register | Verified with visual check. The test report of mineral glass material was present to us for our review. The test report was reviewed and attached to this report.<br>IP68 test was performed under our witnessing.<br>Test result found satisfactory. |

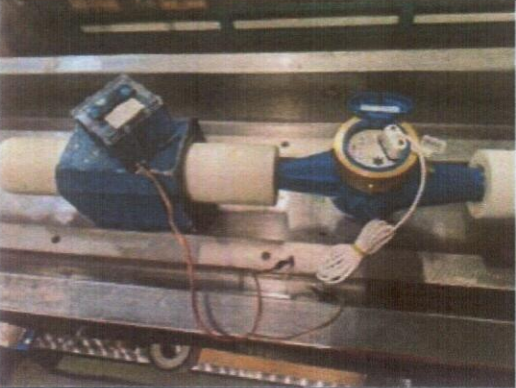
| 8 | Automatic Meter Reader (AMR) | Pulse outputs were functionally tested during accuracy test. It generates a pulse at the rate of at least per 100 lt. Result was found satisfactory. |
