## পরীক্ষণ ও গ্রহণ কমিটির রিপোর্ট

| কাজের নাম | ৪ Supply of sludge incineration rotary kiln Induced draft fan & others equipment for SDIP of Dasherakandi STP. |

# Inspection Report

## 1. Background information

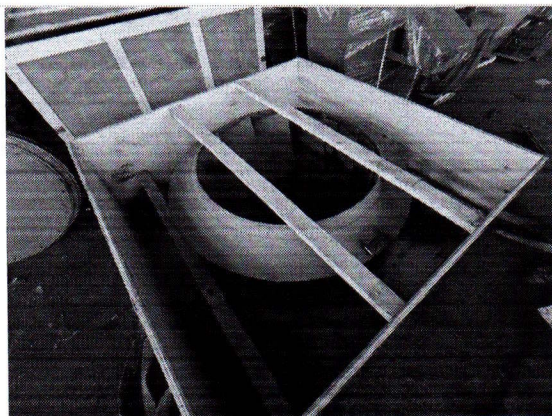
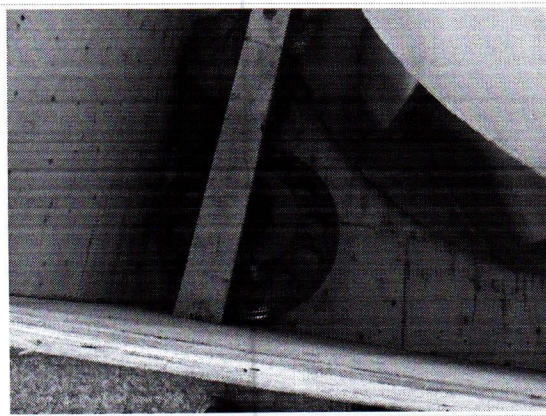
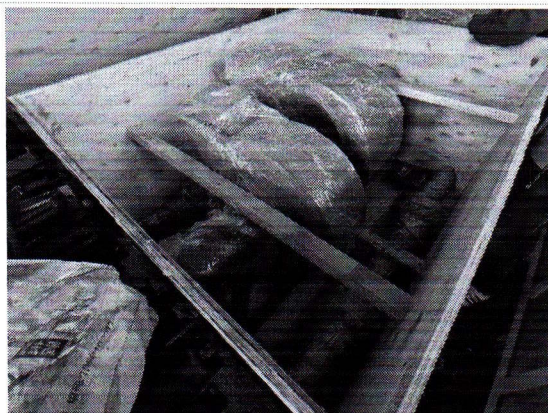
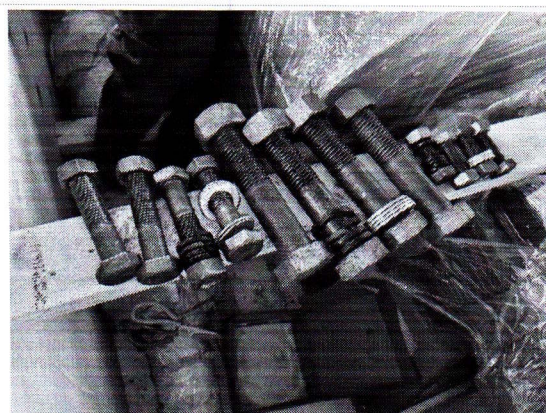
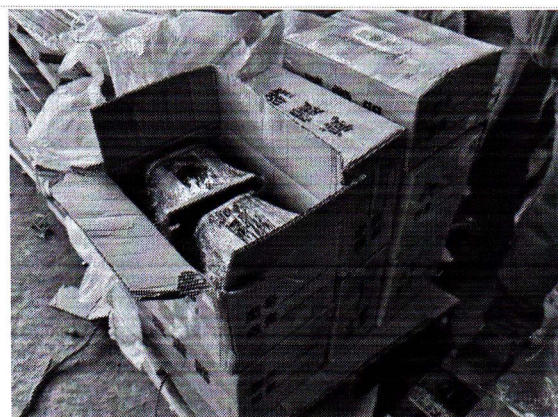
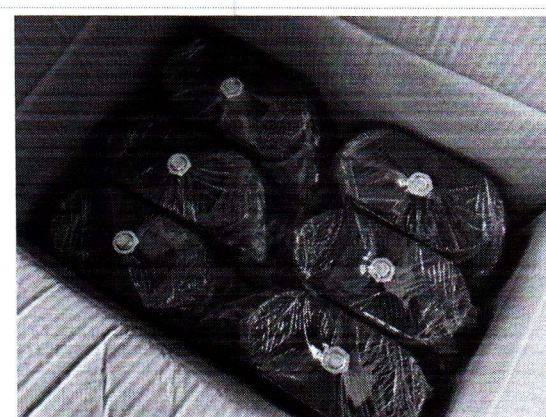
Inspector as per the Goods Name and Quantity list carried out the quantity check, the actual quantity not the same as the goods list, details see below table:

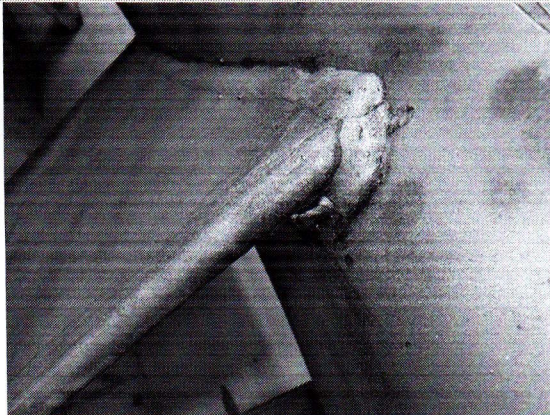
The most weld seams looked smoothly, the but the spatters, pore and local poor weld seam were found on the main induced draft fan impeller.

9. Spatters were found

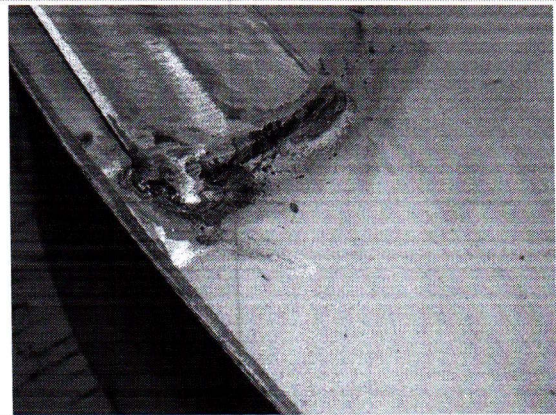
10. Poor weld seam was found

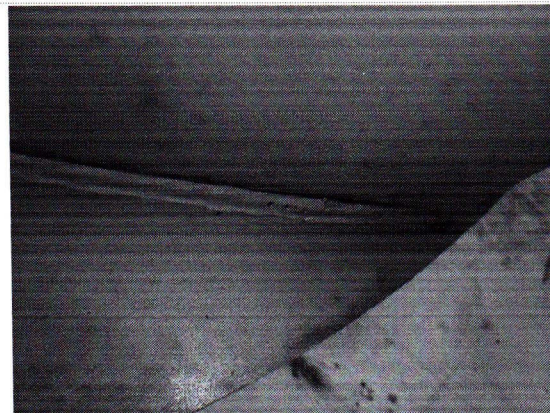
11. Pore was found

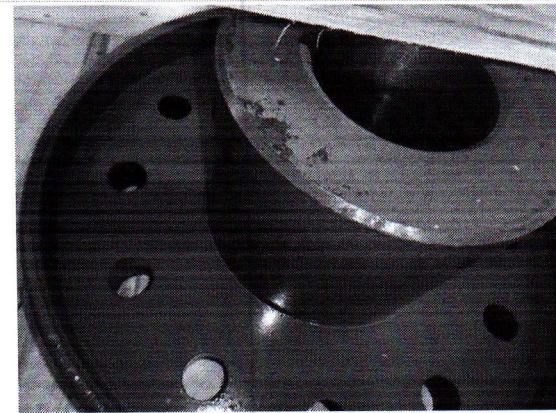
The local paint damage was found on the Coupling for Main induced draft fan surface, and the paint inside the shaft hole has not been removed.

12. Paint damage was found

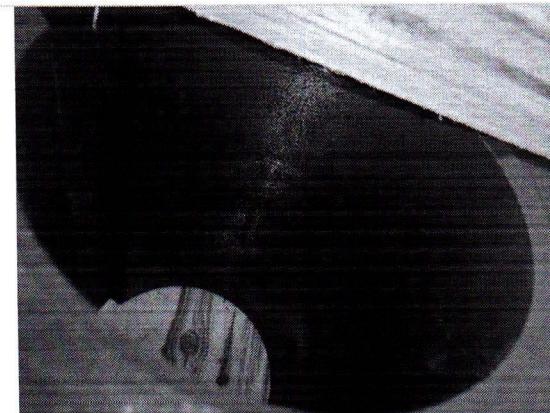
13. Paint was found at the shaft hole inside

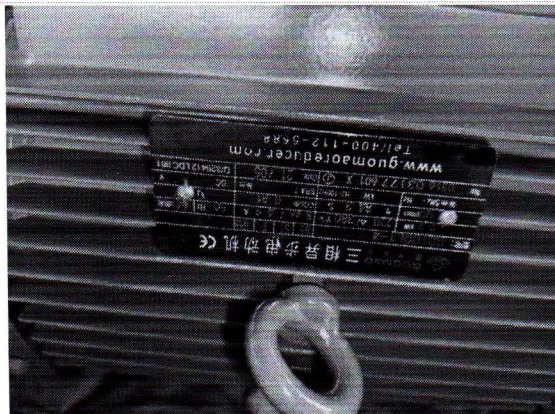
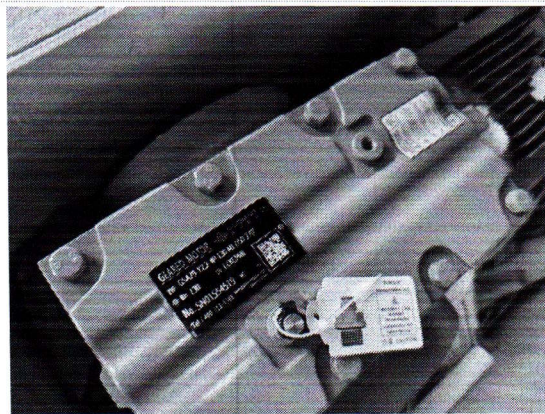
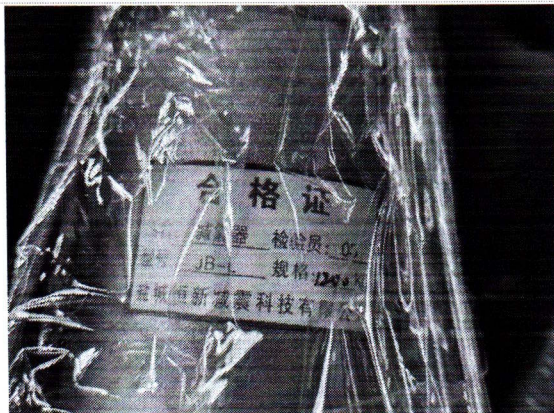
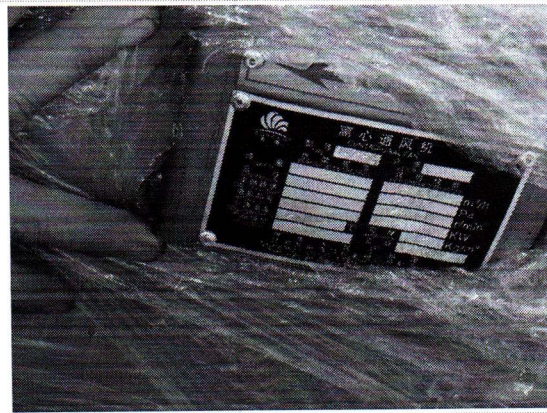
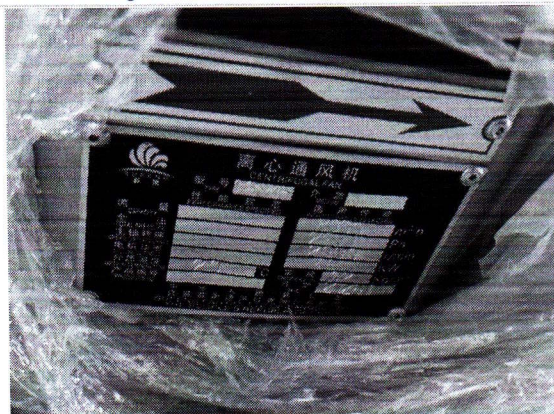
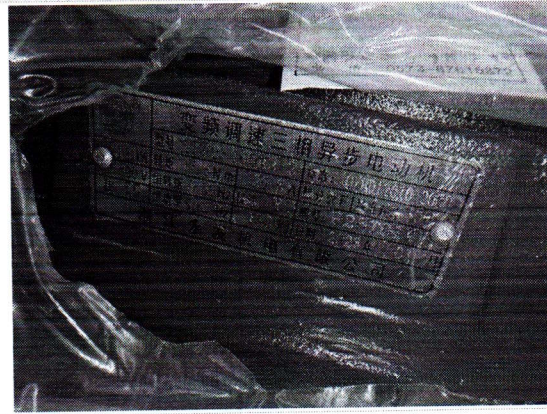
The marking for the main induced draft fan impeller, Main induced draft fan Shaft, Seal for Main induced draft fan and Coupling for Main induced draft fan were not found.

The bearings have been installed on the shafts, the marking and model were not found.

The certificate of conformity was stucked on the Vibration Absorber for Main induced draft fan surface, the type was JB-L, 1200kg, which the same as the Goods Name and Quantity list.

Helical gearworn reducer with motor for SDIP check, total 2sets, the nameplates for the motor and Helical gearworn reducer have been installed, the power was 2.2KW, and the voltage was 380V, the result was acceptable.

Rotary kiln blower for SDIP check, total 2sets, the nameplate and rotate direction marking have been installed on the equipment. Inspector carried out the motor nameplate contents check for the rotary kiln blower for SDIP, one of power (15KW) and voltage (400V) etc., contents the same as the PO. For another one, power (7.5KW) and voltage (400V), due to no relevant information provided before inspection, the result was subject to buyer's evaluation.

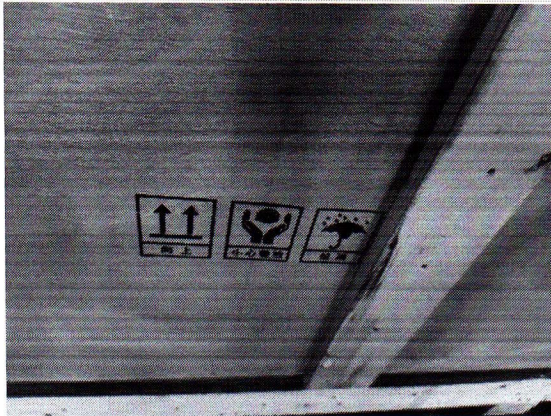
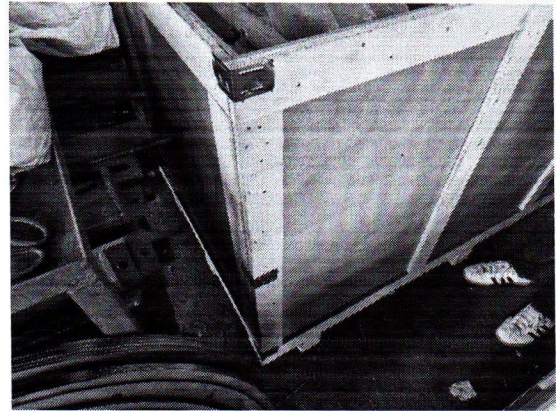
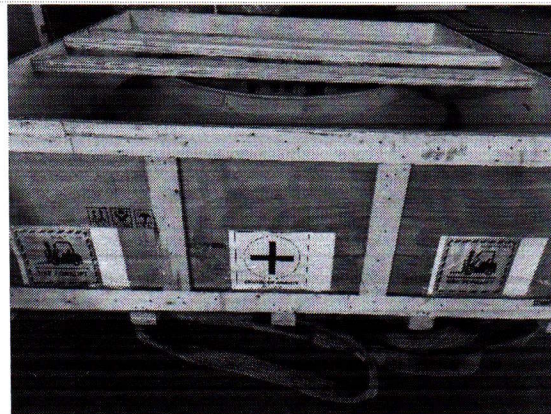
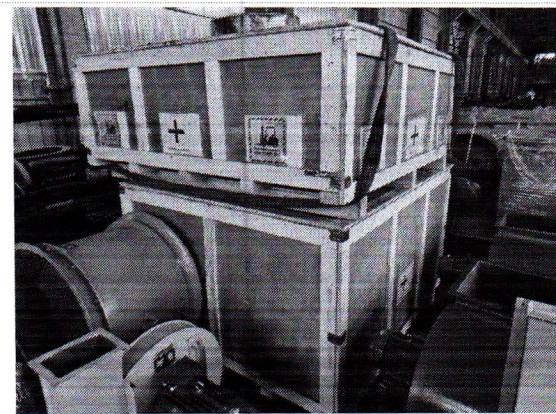
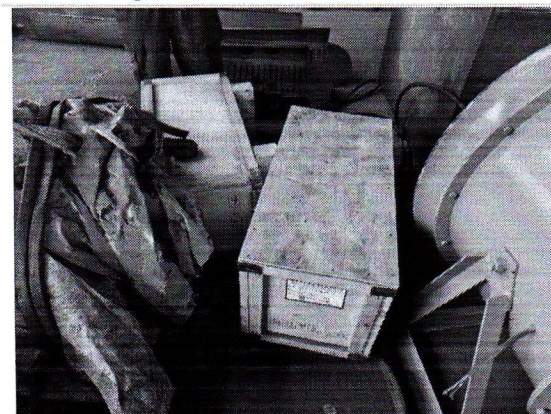
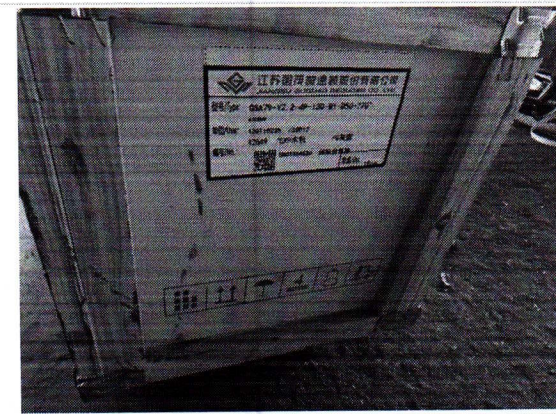
The wooden box was made of plywood and its corners were reinforced with iron sheets.

The center, moisture-proof, forklift and other markings were found on the surface of the wooden box.

The Main induced draft fan Shaft, and Rotary kiln blower for SDIP have been packaged with plastic film.

The fasteners were placed in a paper box.

The helical gearworn reducer with motor for SDIP, fill the four sides with filling materials, and the quality certificate was also placed in the wooden box.
